F-4-52  
Harmony Survey District  
Myersville vicinity  
Private

Ca. 1840-ca. 1930

F-4-52  
Harmony Survey District  
Beallsville  
Frederick County

# Maryland Historical Trust State Historic Sites Inventory Form

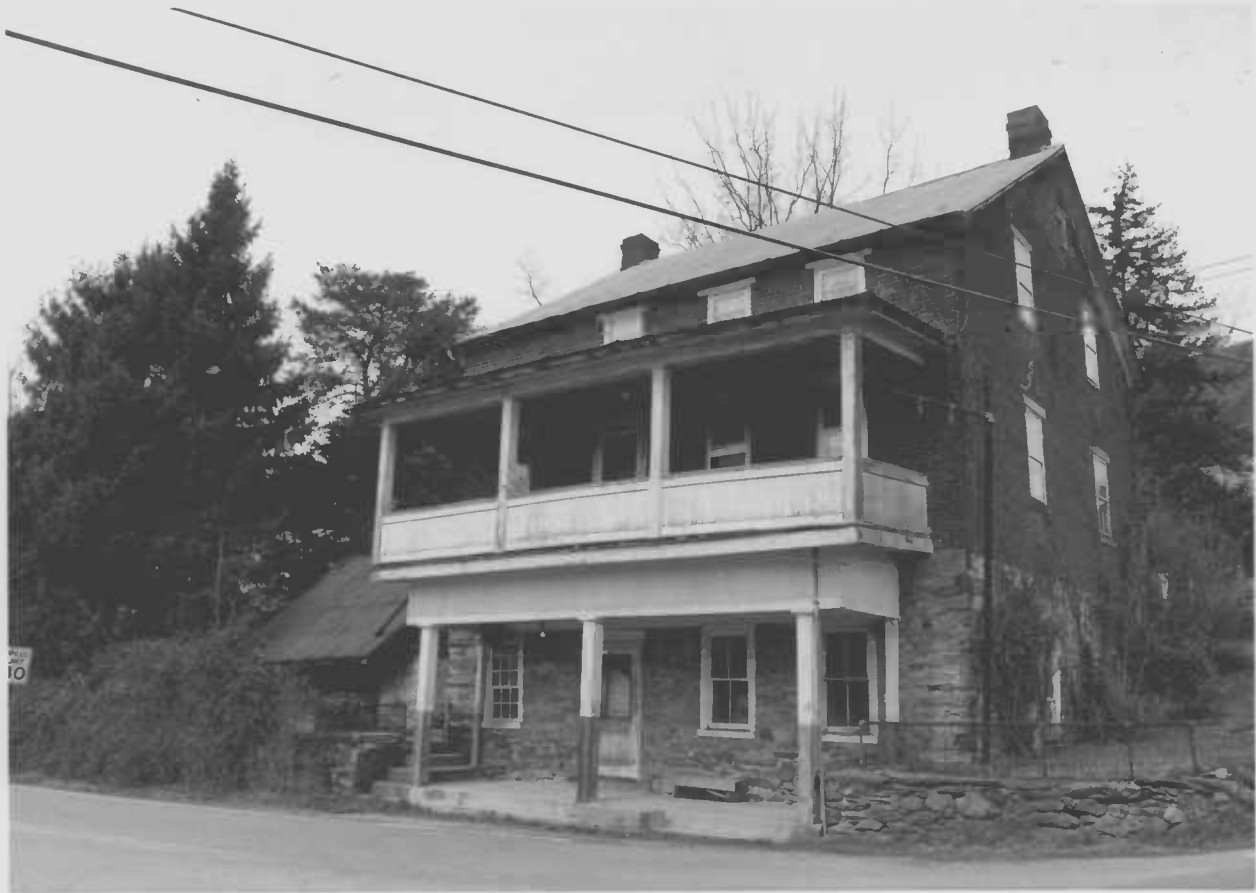
4/12

Branderburg Store and Powhatan, southern +  
central view

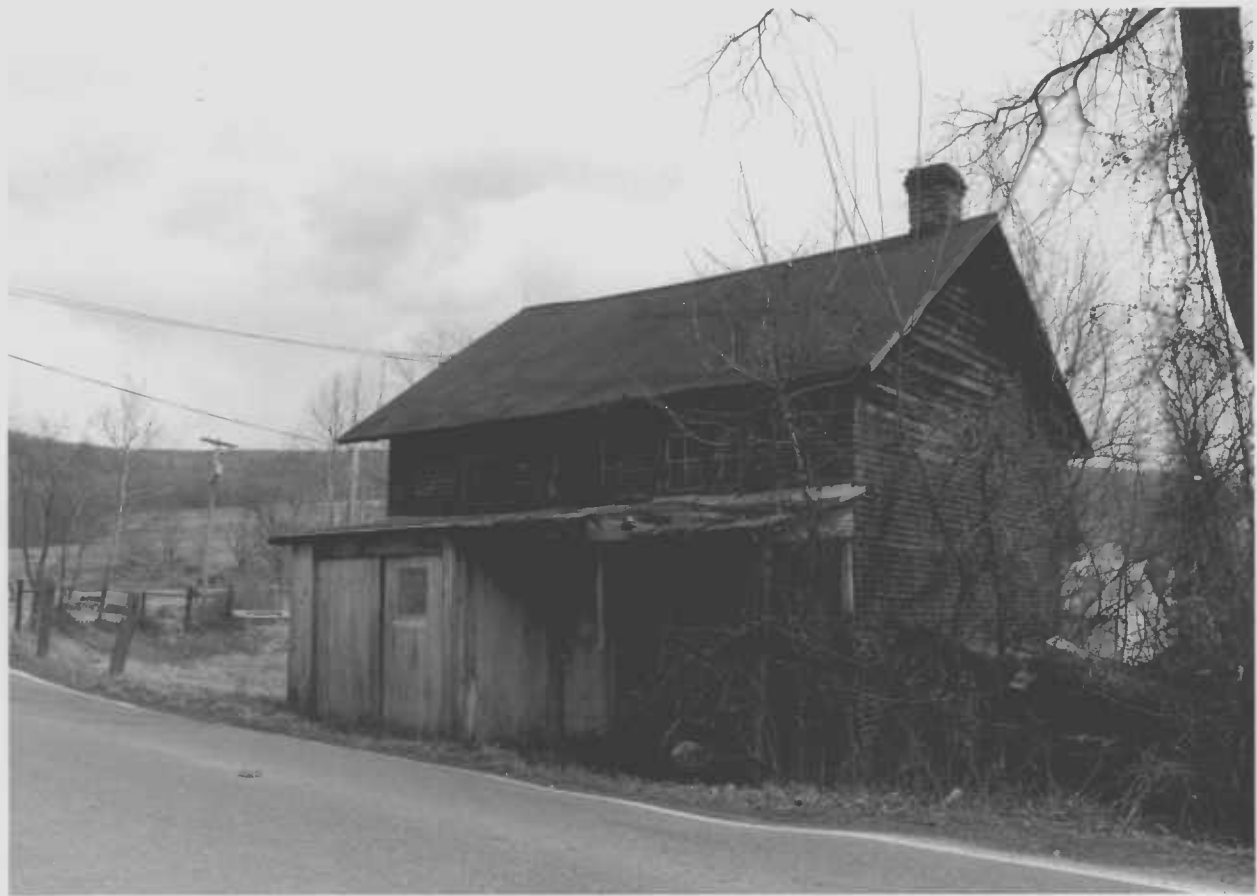
3/12

200 ft wide commercial building, south and  
corner view

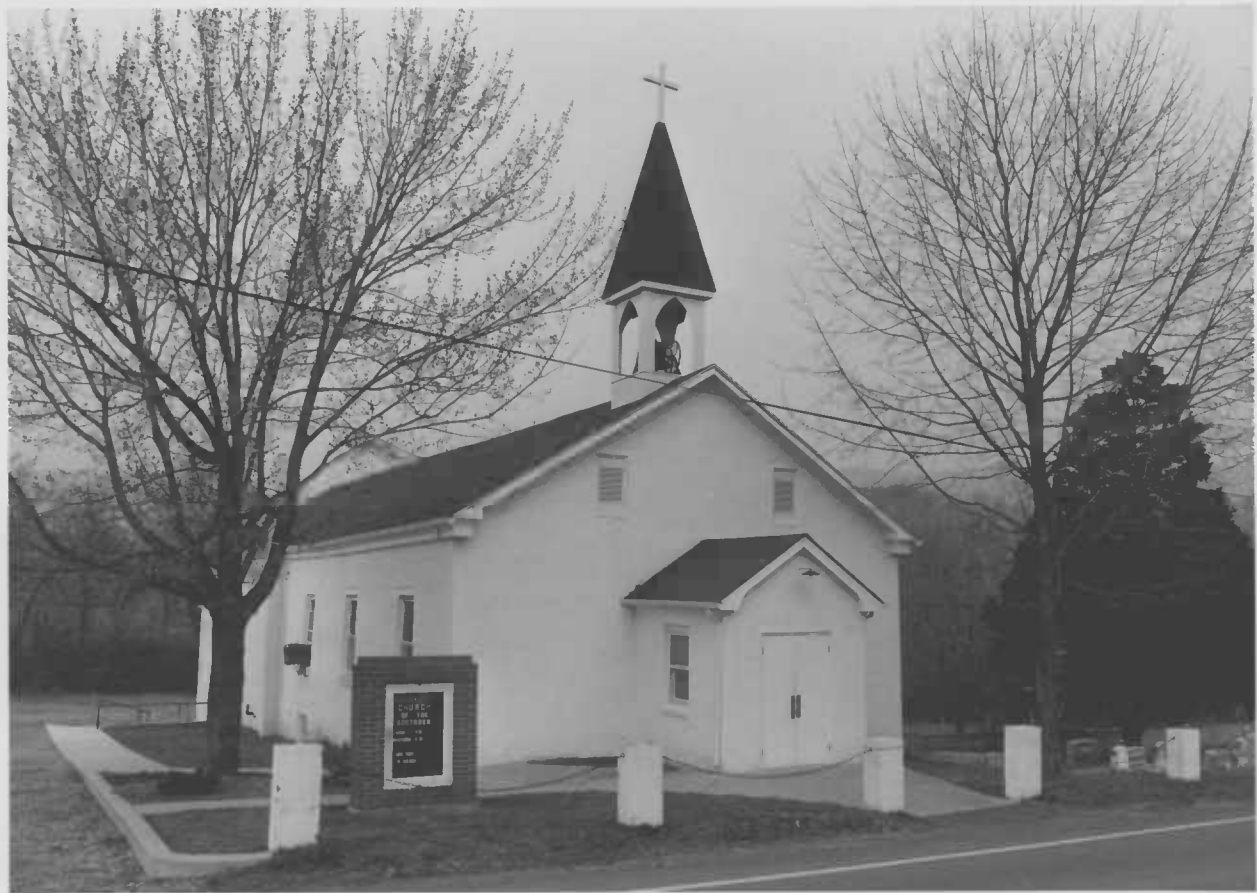
8/12

United Brethren Church, South elevation

Harmony Church of the Brethren: The one-story stone church built about 1870 with additions of the early and middle 20th century is located on the north side of Brethren Church Road at the extreme western end of the survey district. The entire structure has been covered with stucco and is painted white, covering most identifying features of its construction. The stone foundation of the original structure is more uneven than the concrete block of the addition at the north end of the building, although painted white. The hall plan church has a gable roof currently covered with composition material. An open belfry probably added in the late 1890's or early 1900's is located at the south end of the ridge line. A projecting foyer on the south elevation is also a 20th century addition. The windows in the three bays of the east and west elevations of the original part are modern 1/1 replacements. East of the church and partially enclosed by a concrete block fence is the cemetery, with graves dating from about 1790, the approximate date of the congregation's formation.

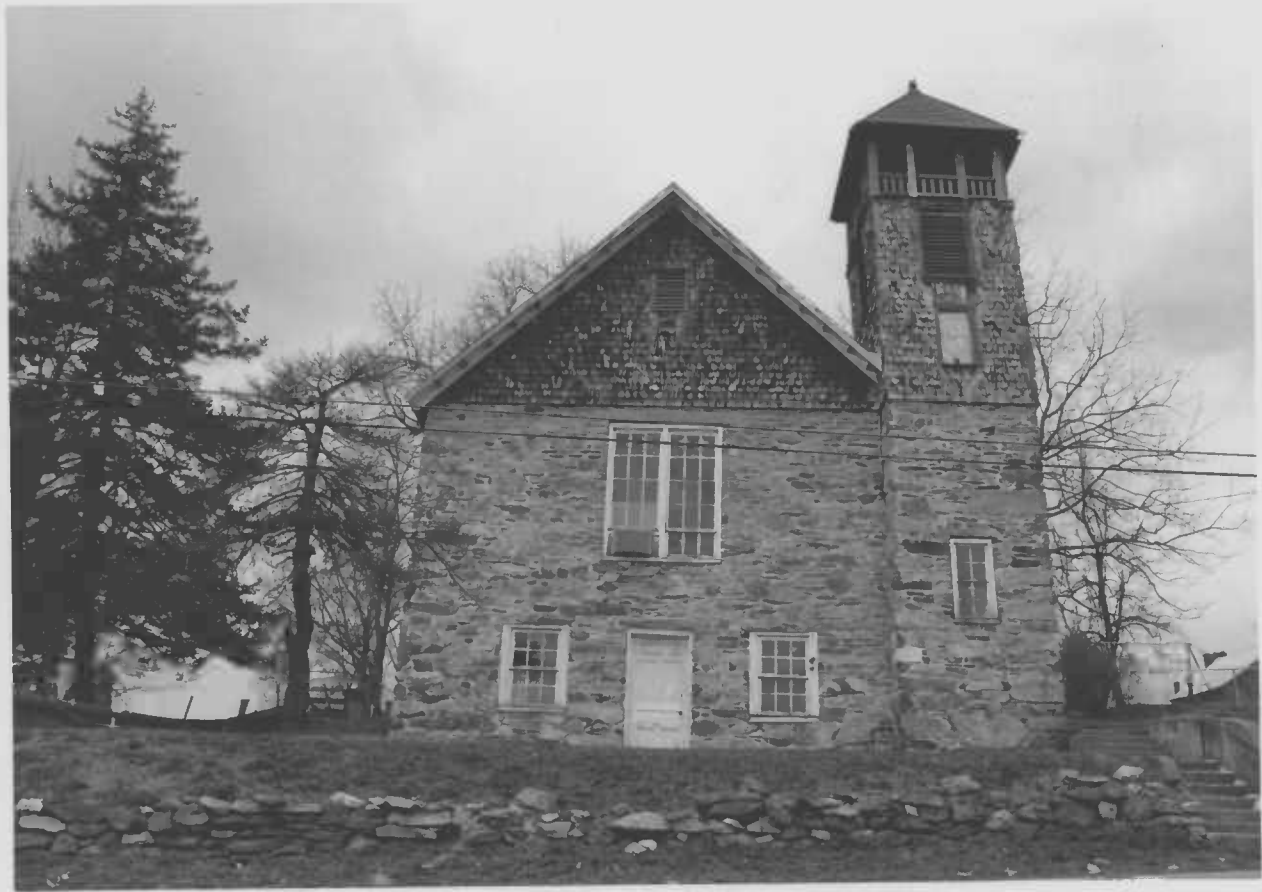
9/12

1 - 1/2 mi. N.W. of Greenwell, 1st  
Reformed Church east elevation

Reformed Church: Located on the west side of Harmony Road facing the intersection with Hollow Road, the 1909 stone church has two stories with a bell tower at the northeast corner. The gables and the upper level of the bell tower are covered with wood shingles, which are currently very weathered and somewhat deteriorated. The gable roof is covered with pressed metal. The east elevation has three bays with a center entry through a simple 6-panel door. The flanking windows are 6/6 on the first story. The upper story windows are 12/3 with stenciled stained glass. The tower contains another entrance with double paneled doors in the north side. The north and south elevations have three bays, with stenciled stained glass in the south elevation windows and clear glass on the north elevation. The west elevation projects from the main bulk of the church, probably containing the vestry. At the rear of the building are two deteriorated frame privies. The church building is currently used for community activities and is owned by a local civic band.

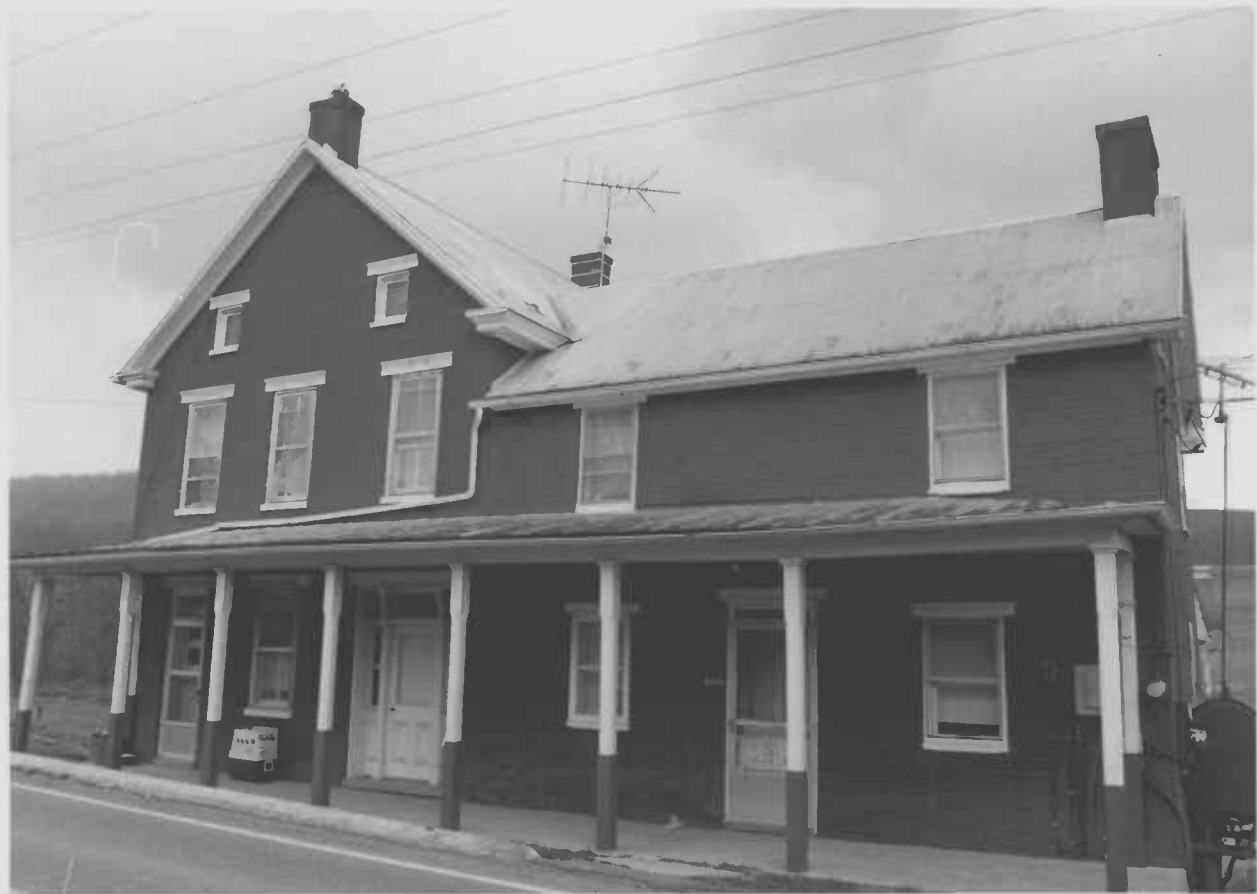
10/12

Shirley's House, 9845 Hormony Rd., West  
elevation

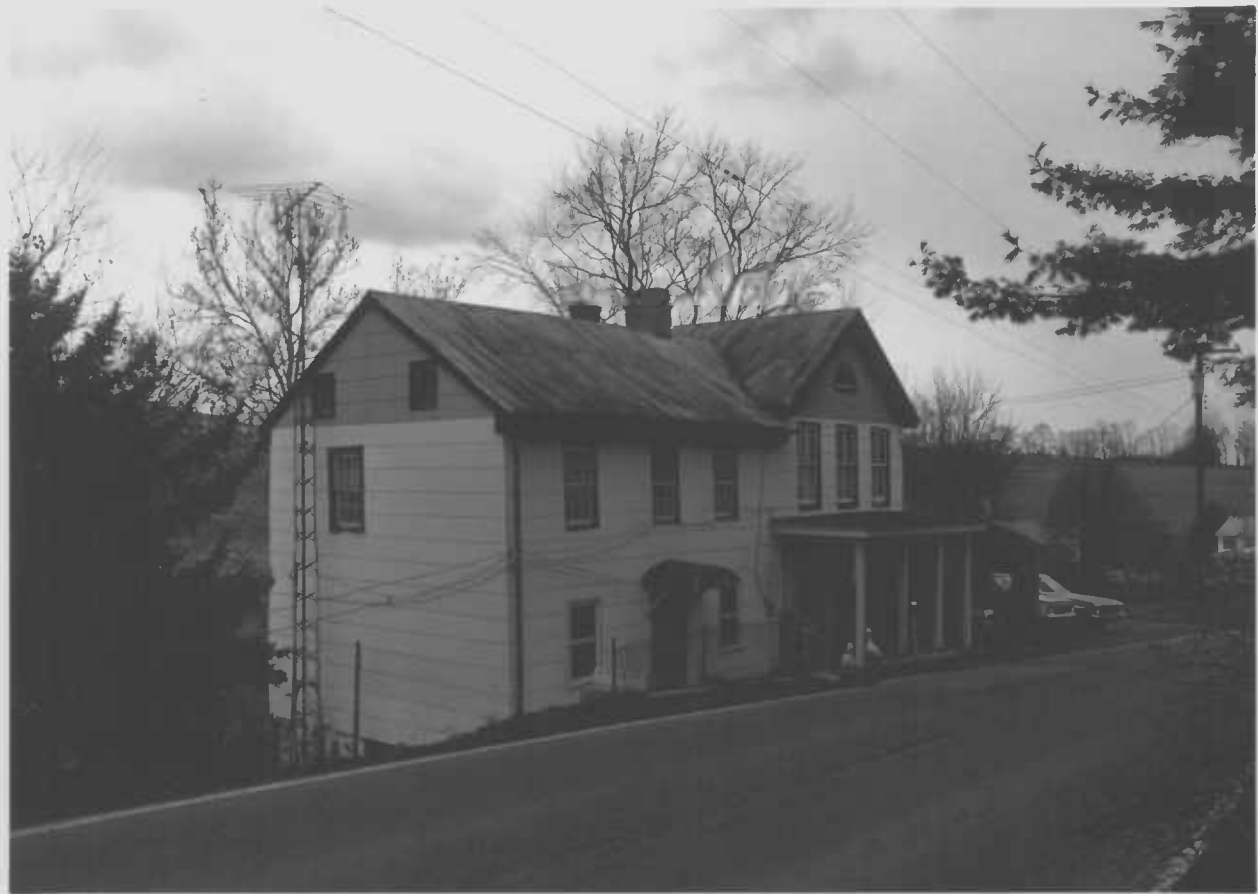
11/12

9521 Harmony Road v. 4th & 1st corner view

9521 Harmony Road: This building has a similar plan to the Smith-Unverzagt House at 9545 Harmony. It has two sections, one a residence with two stories and three bays adjoining a gable-fronted, three-bay section presumably once a store. It has the same center entrance in each section and the semi-circular window in the gable as in the Smith-Unverzagt building. The exterior here is asbestos shingles and the sash is varied: 1/1 on the first story of both sections, 2/2 on the second story of the gable section, and 6/6 on the second story of the residence. The roof is covered with corrugated metal. The entrance to the gable section has a 2-light transom and a glazed panel door. A one story porch extends across the entire facade and a modern carport is attached to the south elevation of the building. This property was also owned by John Brandenburg, the blacksmith, and later by Henry Unverzagt. Probably built about 1840-50, its possible use as a store is unconfirmed by title research or historical maps.
